Solving Common Coating Problems

Using this chart

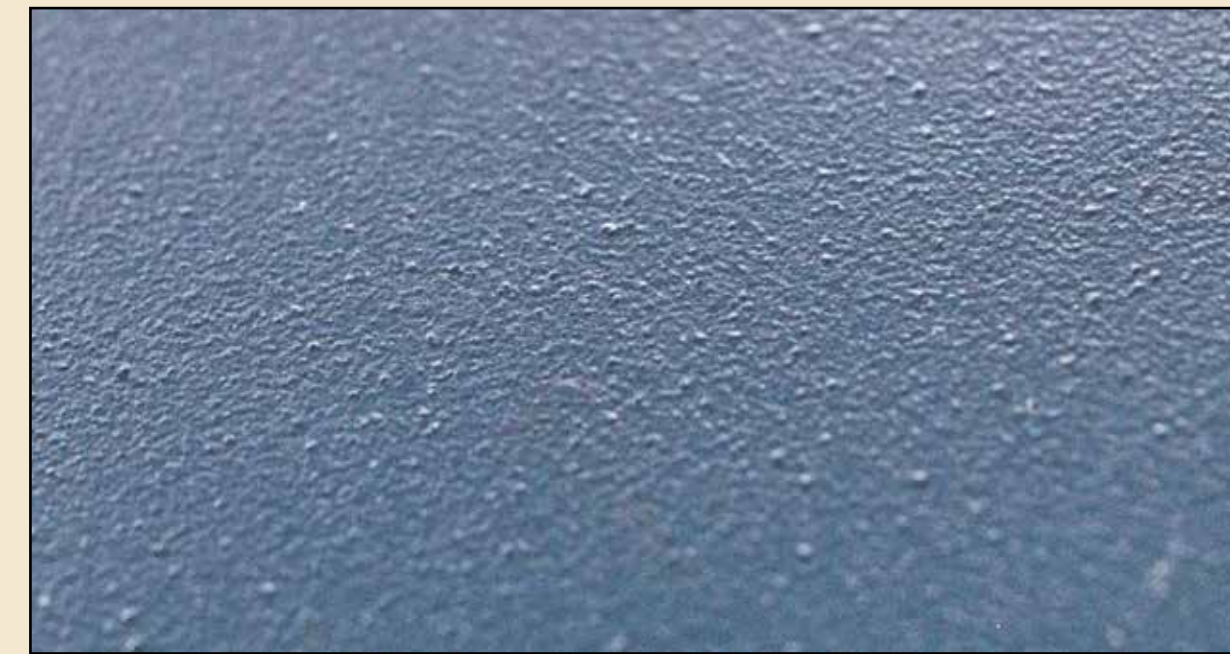
Blisters

- Appearance**
Small blister-like bumps on the coating surface.
- Probable causes**
1. Coating has been applied too thickly.
 2. Rapid evaporation of solvents (using a solvent that is too volatile), or increasing part temperature too rapidly.
- Suggested solutions**
1. Remove coating and reapply a thinner coat.
 2. Remove coating, preheat parts, then recoat and cure immediately.
 3. Add small amount of slow-evaporating solvent.

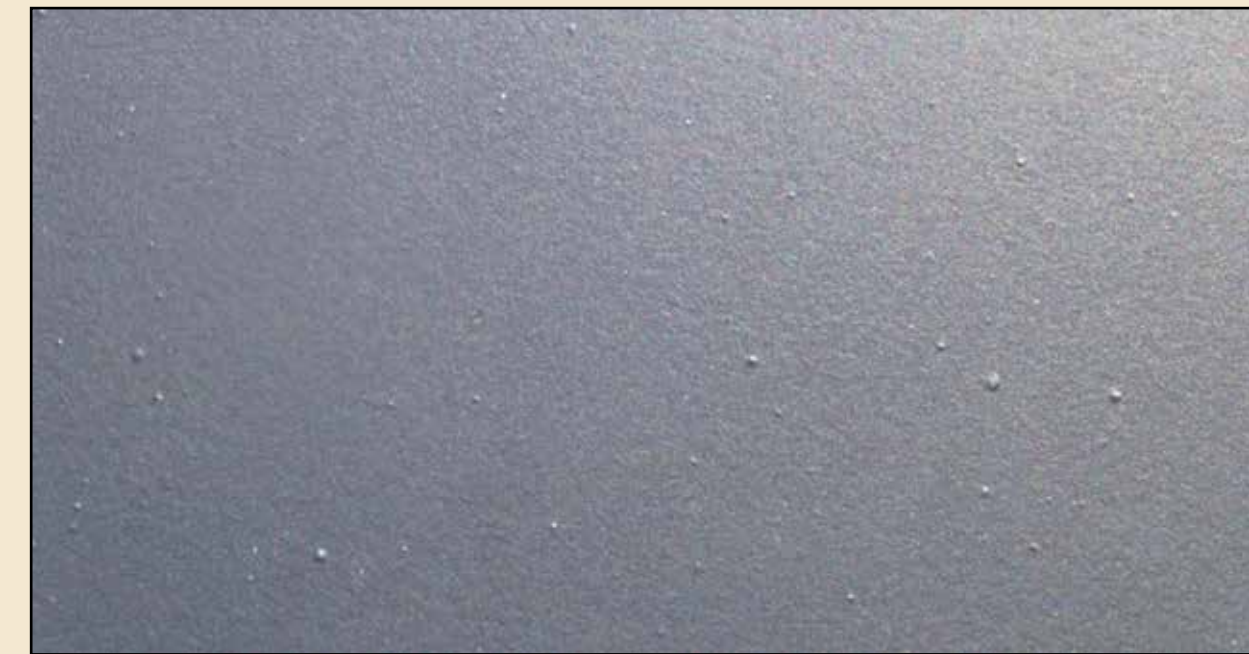
Bubbles, pinholes

- Appearance**
Many small pockmarks or tiny holes in the coating.
- Probable causes**
1. Excessive agitation, causing coating to foam, trapping gas or air in bubbles.
 2. Excessive pumping or a leaking pump.
 3. Rapid evaporation of solvent.
- Suggested solutions**
1. Reduce agitation in tank and check pumping process.
 2. Add slow-evaporating solvent.
 3. Warm parts more gradually, flash briefly before curing.

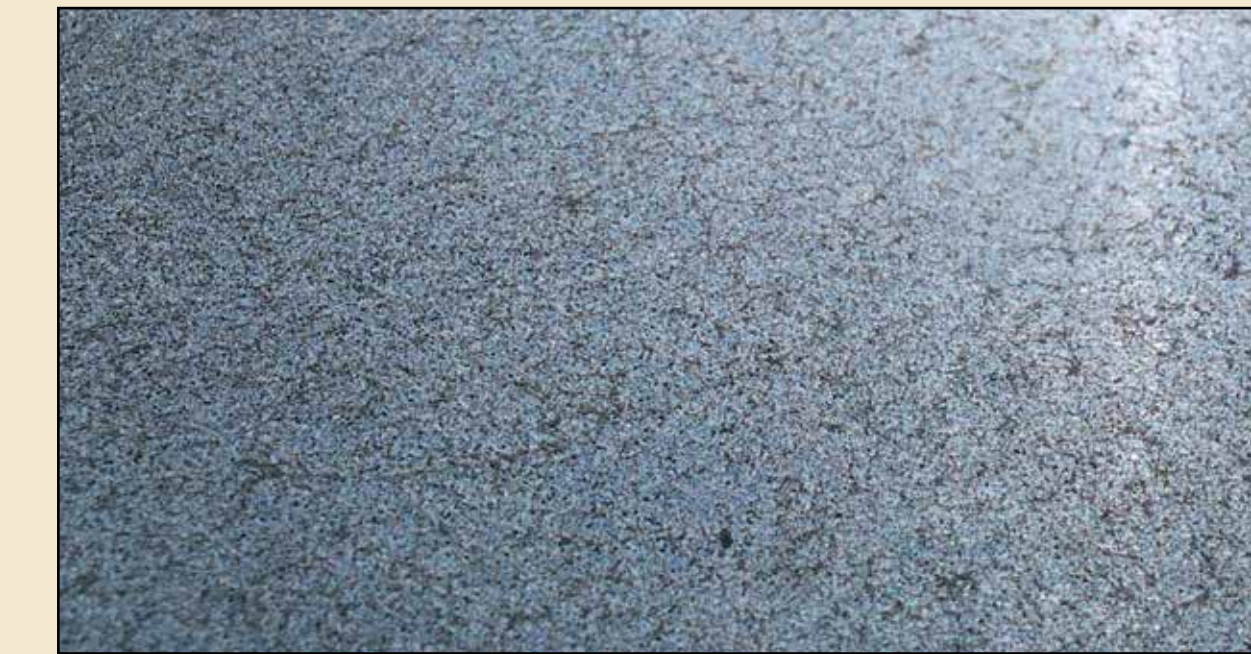
Cobwebbing

- Appearance**
Small strands of coating resin on the surface.
- Probable cause**
Fluid coating is drying (as it is sprayed) before it reaches the surface to be coated.
- Suggested solutions**
1. Reduce the air pressure in the delivery system to prevent premature drying.
 2. Change to a solvent that dries more slowly.
 3. Reduce viscosity.

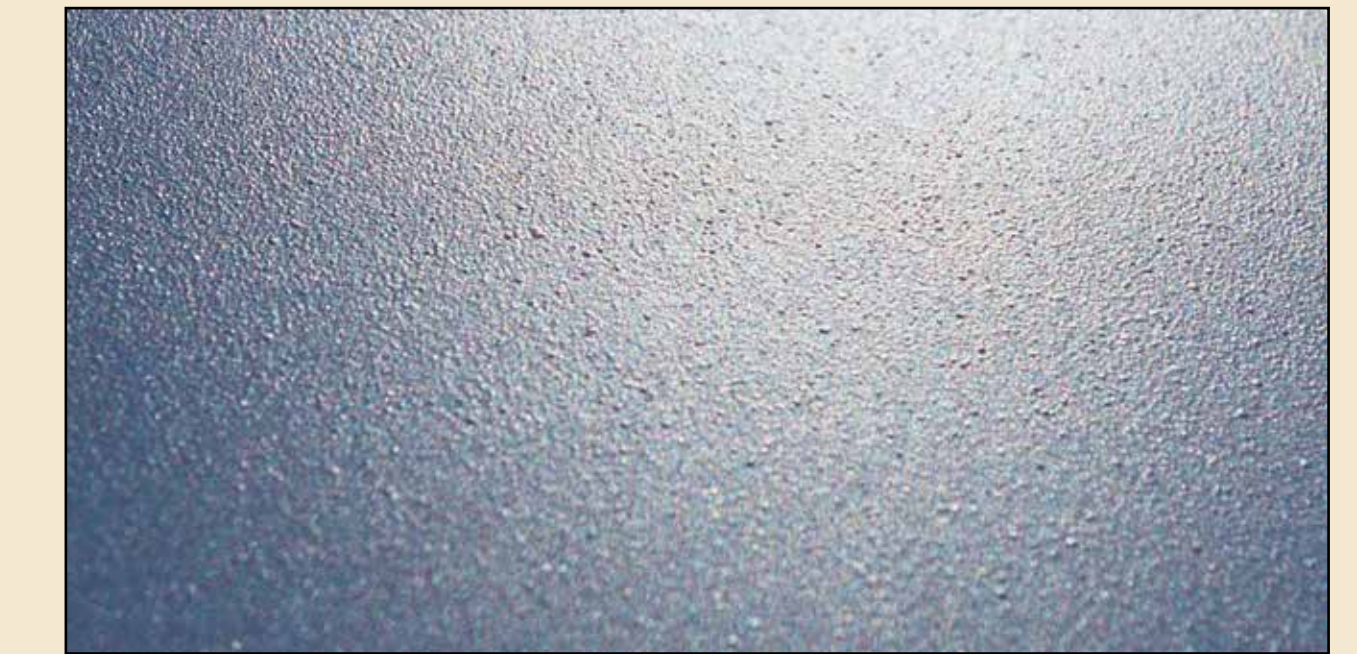
Dry spray

- Appearance**
A rough, mottled surface, similar to orange peel.
- Probable cause**
The coating is losing too much solvent as it is propelled toward the surface by the spray gun.
- Suggested solutions**
1. Move the spray gun closer to the surface; reduce the velocity of the spray; or increase the ratio of coating to air in the spray.
 2. Change to a solvent that dries more slowly.

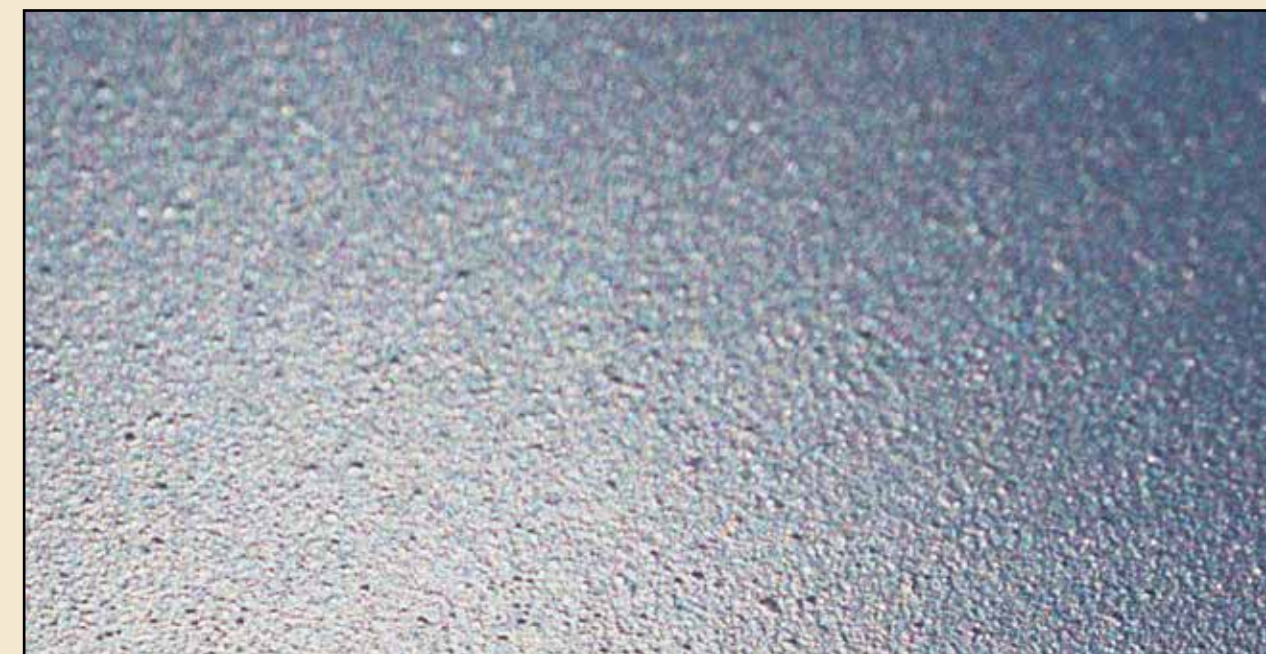
Eruptions in die-cast parts

- Appearance**
Occasional, random eruptions and/or small pockmarks.
- Probable cause**
Microcavities containing air in the metal. The air expands during curing, erupting (outgassing) and leaving either a small eruption or a crater.
- Suggested solutions**
1. Force eruptions prior to coating by preheating the parts to a temperature above the cure temperature. If no blisters appear, let parts cool, then coat and cure. If blisters still appear, the die-caster must make adjustments.
 2. Select coating with lower cure temperature.

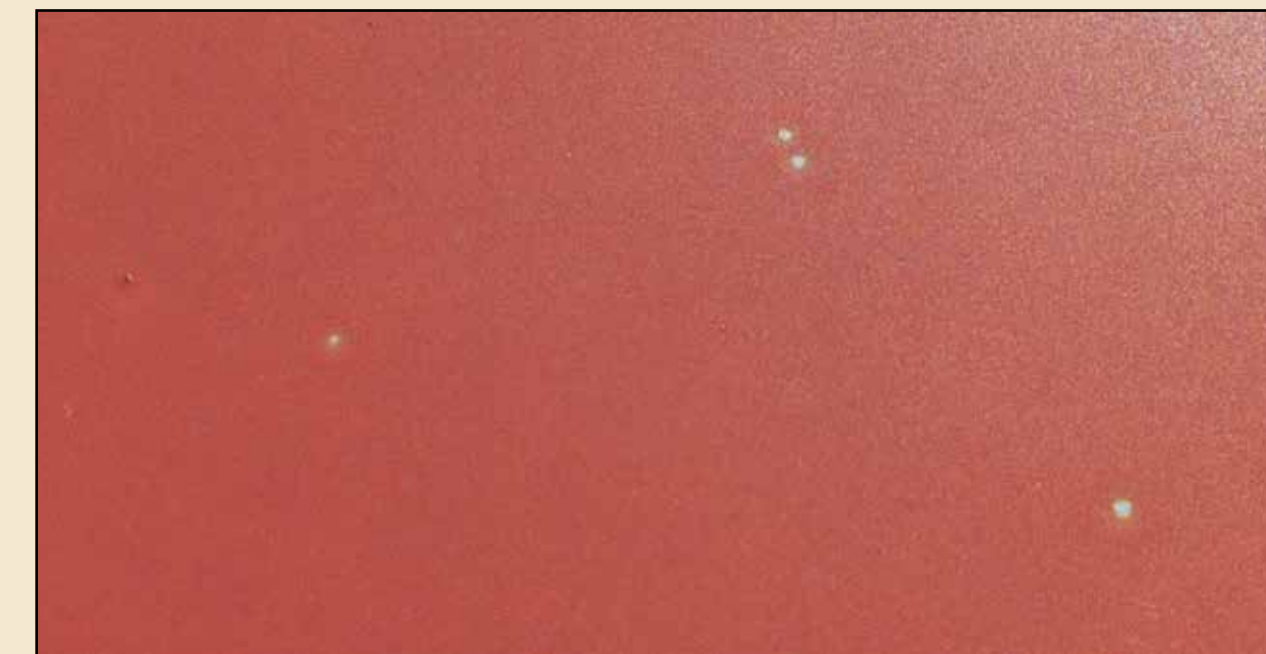
Fish eyes

- Appearance**
Round, crater-like holes that penetrate to the substrate.
- Probable cause**
Contaminants that prevent coating from wetting out the surface (such as grease from fingerprints or oil in the compressed air).
- Suggested solutions**
1. Review the handling, cleaning and surface preparation procedures to assure surface is free from contamination prior to coating.
 2. Check for possibility of silicone contamination.
 3. Install/check efficiency of oil/water trap.

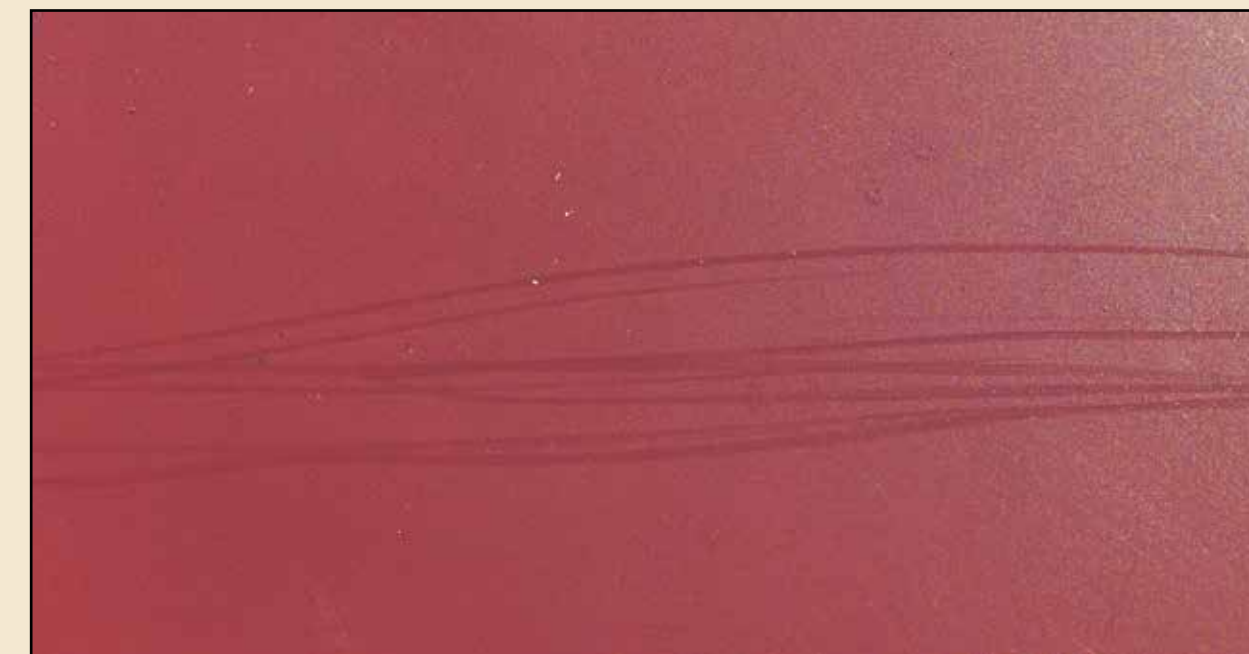
Hazing, low gloss

- Appearance**
Dull, low reflective appearance of coating.
- Probable causes**
1. Film of material such as PTFE that rises to the surface (does not harm performance), low cure temperature/time.
 2. Presence of moisture (humidity) during coating, leaving a rough, low-gloss surface.
 3. Oven fouling. Low film thickness or rough substrate.
- Suggested solutions**
1. Rapid cooldown may improve gloss, increasing cure temp./time may eliminate hazing. Check oven, substrate.
 2. Check water traps for moisture. Check DFT.

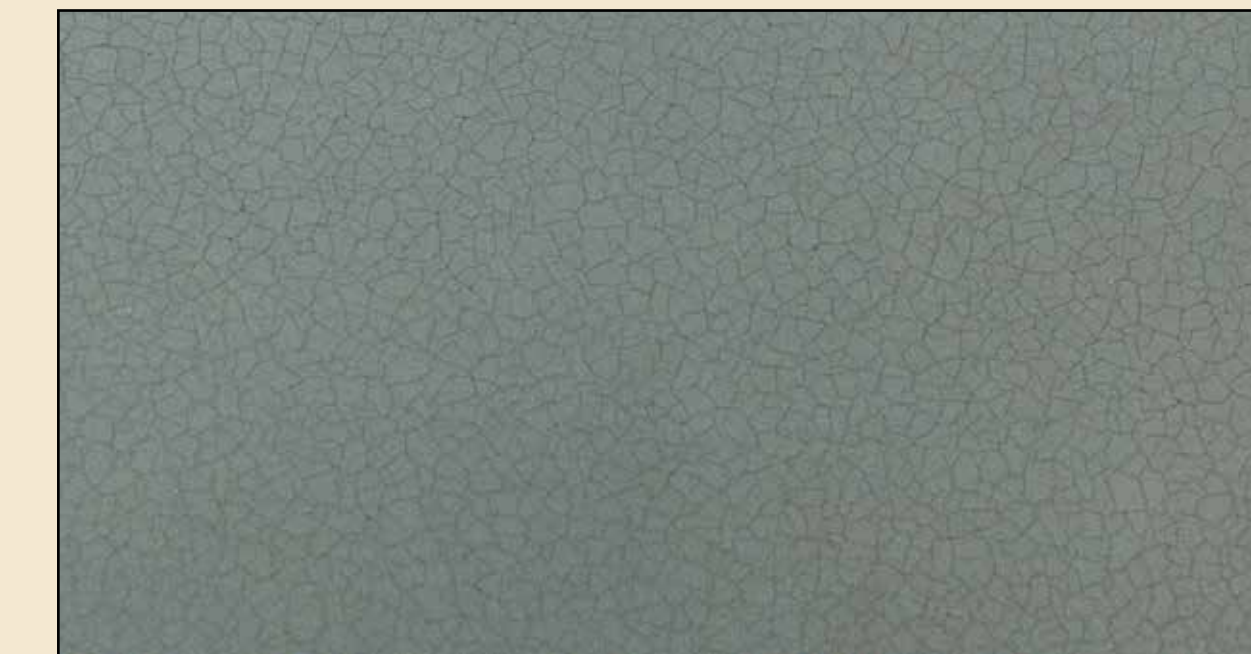
Mud cracking

- Appearance**
Thousands of tiny splits or cracks in the coating surface resembling dried mud.
- Probable cause**
1. The coating has been applied too thickly. (Note: this condition most often occurs in waterborne coatings.)
2. Coating flashed too quickly or too high a temperature.
- Suggested solutions**
1. Reduce the application viscosity.
 2. Apply a thinner film.
 3. Check flashing process (see Product Data Sheet).

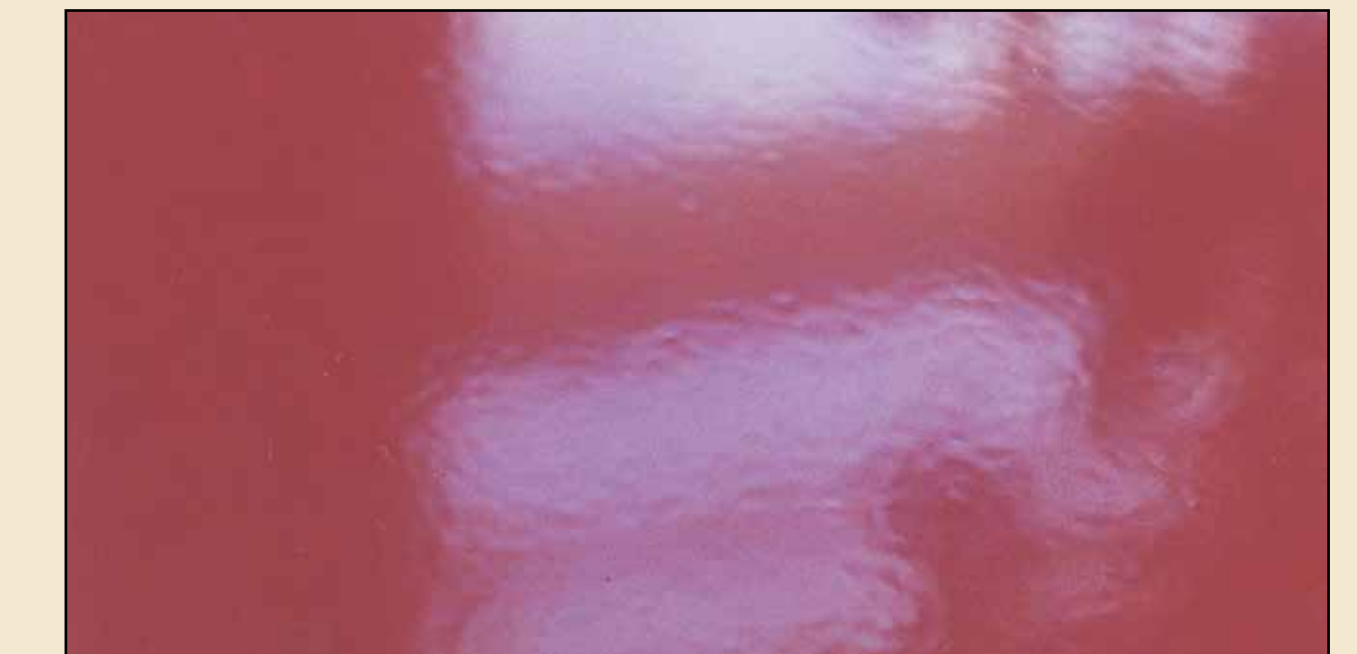
Orange peel

- Appearance**
Textured coating surface resembling skin of an orange.
- Probable causes**
1. High viscosity of the coating material.
 2. High temperatures causing rapid solvent loss.
- Suggested solutions**
1. Decrease the viscosity and lower air pressure.
 2. Reduce the temperature of the part.

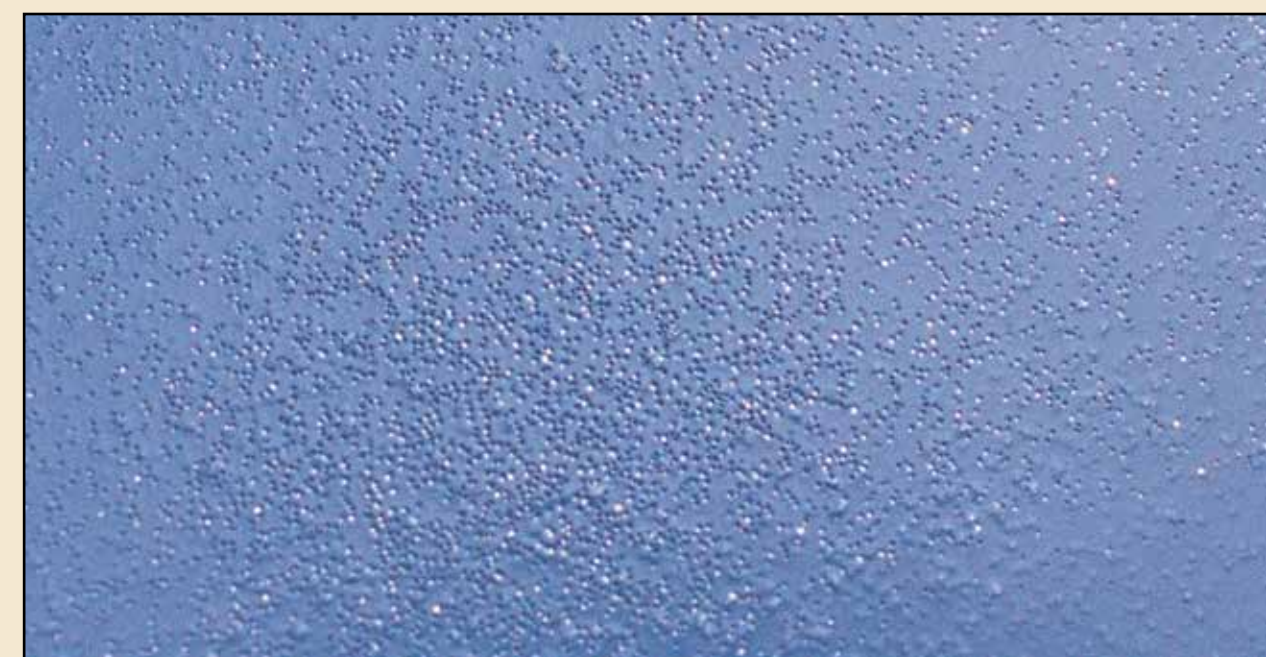
Overspray cratering

- Appearance**
Small particles of coating that reach a surface not intentionally sprayed (such as overspray from an interior non-stick reaching the exterior of a pan).
- Probable cause**
Too much overspray in application process.
- Suggested solutions**
1. Move the spray gun closer to the surface; reduce the velocity of the spray; or increase the ratio of coating to air in the spray.
 2. Mask part to avoid overspray reaching other surfaces.
 3. Increase air exhaust around parts to remove spray.

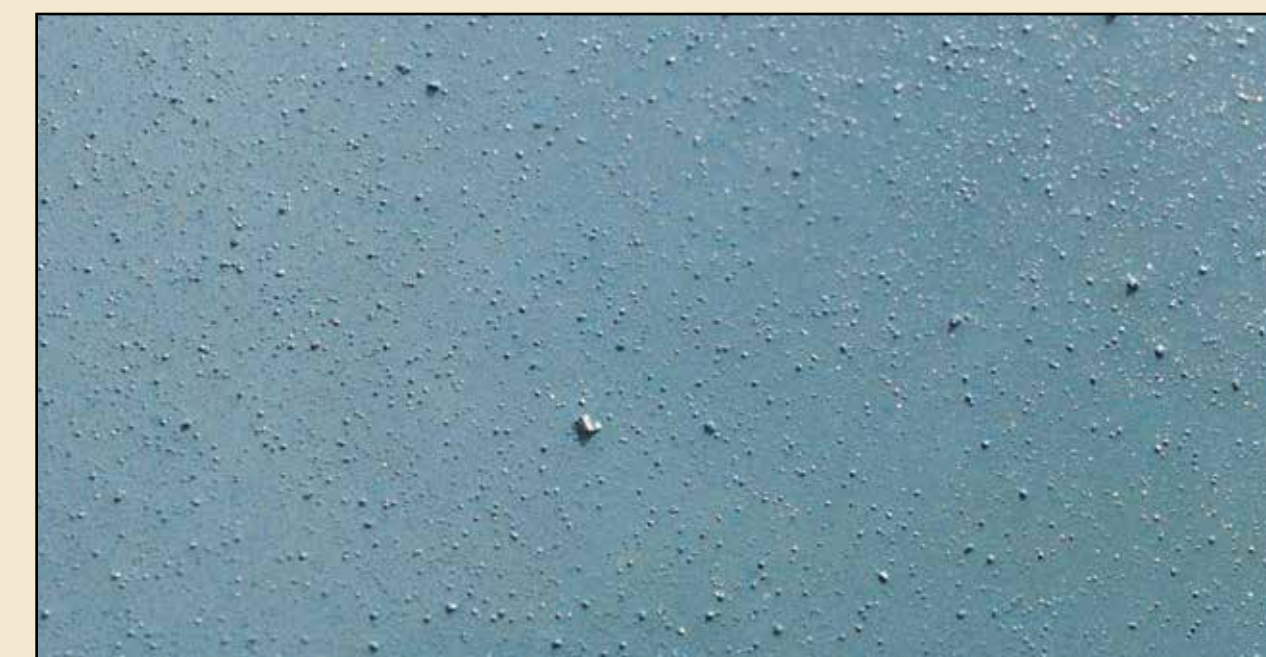
Particulate contamination

- Appearance**
Hard bits (particles) on surface of coated parts.
- Probable causes**
1. Dried coating inside container falling back into coating.
 2. Airborne particles either in spray area or oven.
- Suggested solution**
1. Filter coating before using.
 2. Keep spray area clean and free of dust.
 3. Vacuum particulate matter from oven.

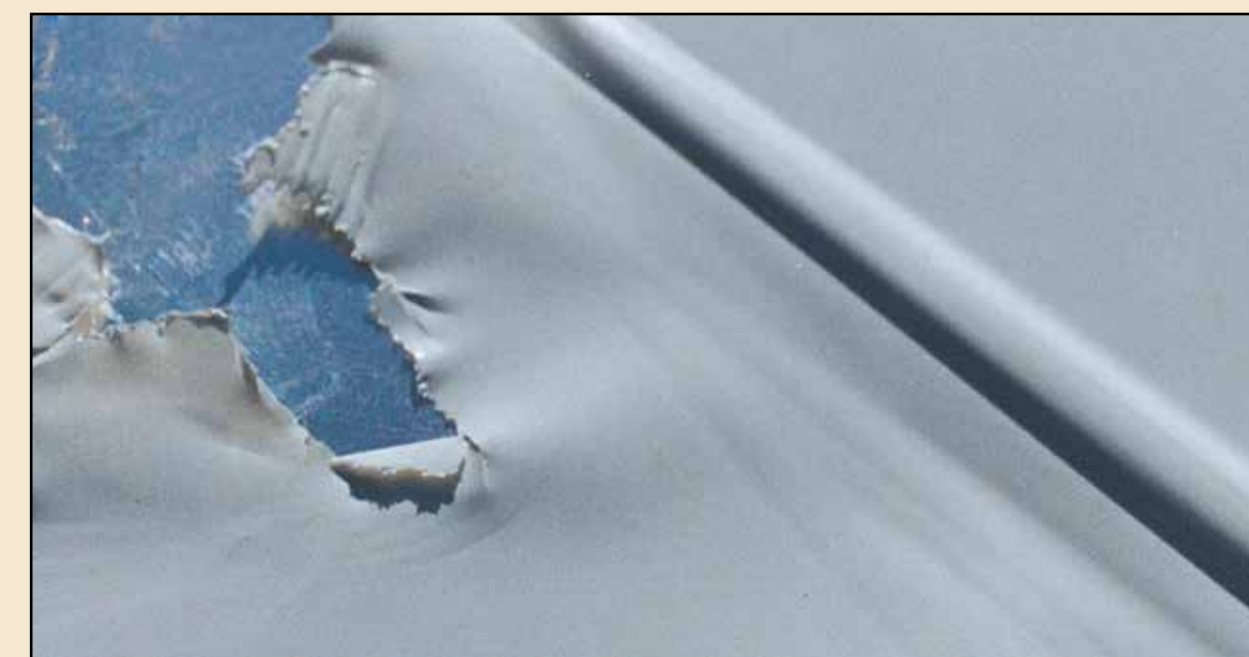
Peeling, flaking

- Appearance**
Sections of coating that lift easily off the substrate.
- Probable causes**
1. Contamination, improper surface preparation.
 2. Insufficient mixing.
 3. Improper cure.
- Suggested solutions**
1. Improve process of cleaning substrate to assure no forming oils or previous coatings remain.
 2. Mix according to Product Data Sheet.
 3. Check curing procedure with Product Data Sheet.

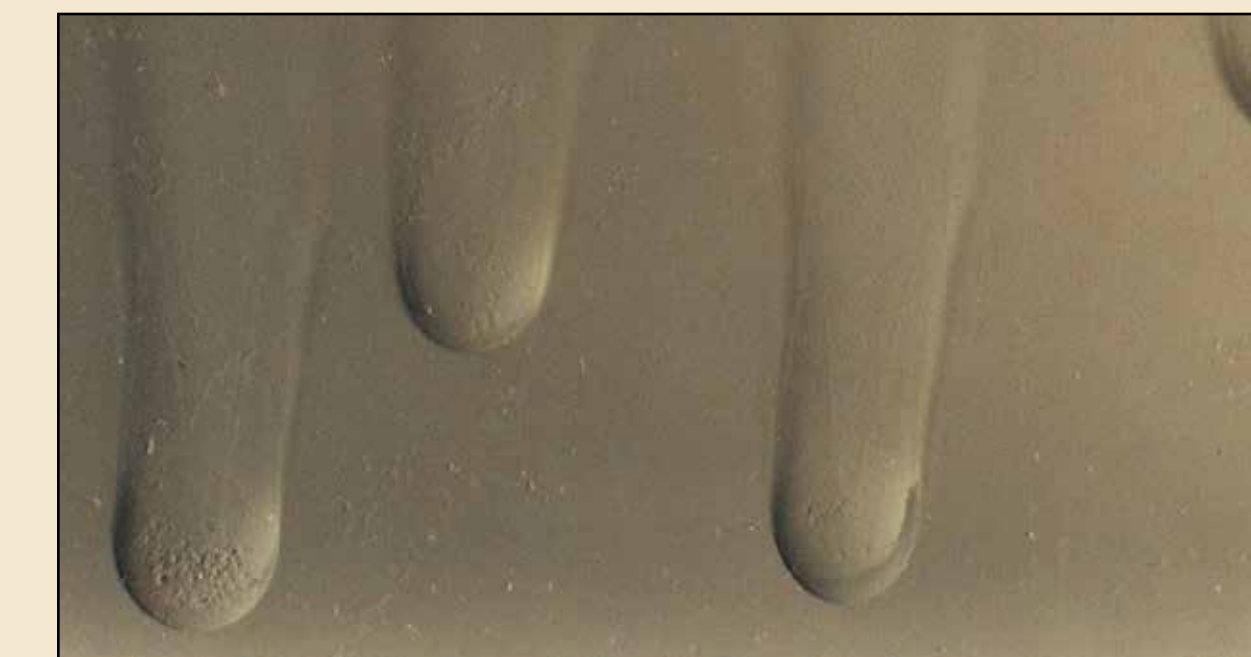
Sagging

- Appearance**
Coating that runs before drying, leaving raised rivulets.
- Probable causes**
1. Low viscosity of coating material.
 2. Incorrect thinning solvent used.
 3. Coating is applied too thickly.
- Suggested solutions**
1. Avoid reducing coating or use solvent with higher evaporation rate (check Product Data Sheet).
 2. Apply thinner coats.
 3. Apply to pre-heated parts.
